ABS designs mounted to similar wheel bearings on some Chevrolet models can functionally different. This can lead to wrong bearing unit being fitted and result in ABS fault codes being activated on likes of Epica models around 2007. This can apply due to car production / equipment changovers around this period.

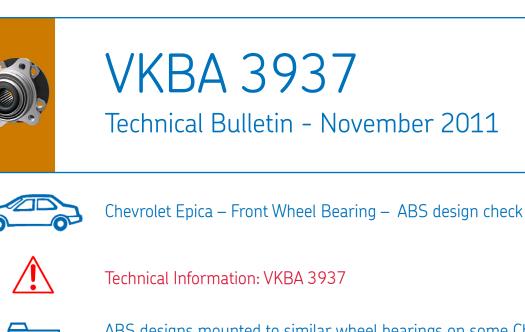
Note: different ABS sensor ring design mounted to back of hub

Design type1 VKBA 3937 fitment OK

Design type 2 NOT VKBA 3937

Please ensure prior to new bearing fitment. The bearing and ABS design must be checked – compare with old part on car to ensure correct version. This can easily be confirmed by the visual check on back of unit.
