ProViu®360

2nd Generation Surround View

Next Generation Surround View

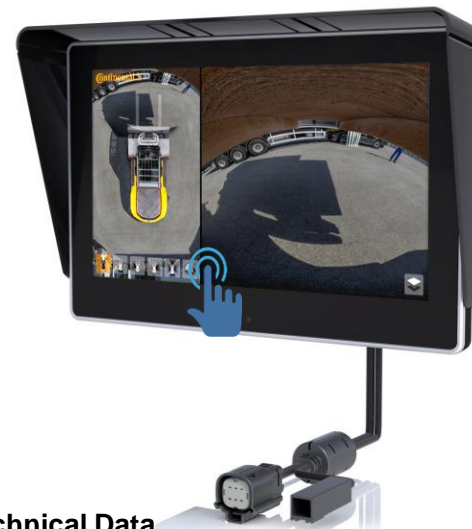
- › HD surround view system
- › 4x Megapixel **HDR** Cameras
- › Enhanced image quality especially under low light conditions
- › Genuine real time delivery at 30fps
- › Smaller component size for better vehicle integration
- › based on years of experience with generation 1

- › Monitor: 10.1" HD Touch-Display
- › Camera: 1,3 Megapixel HDR Camera
- › Video Processing Unit

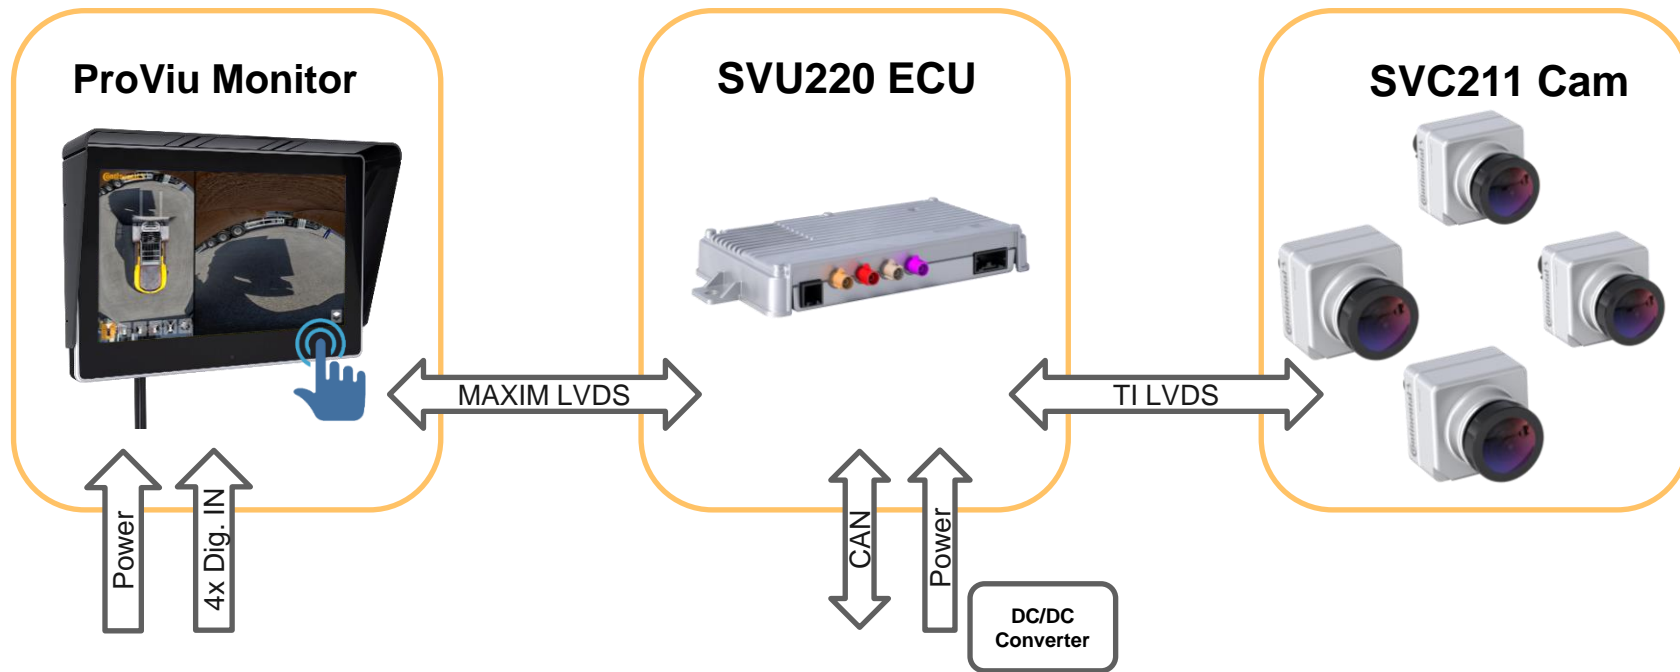
ProViu®360 2nd gen Camera Housing Design

- › 40° Angle for optimized Vision
- › 4 x M6 Screws for fixation
- › Rubber Plate for Vibration optimization
- › Acc. To ECE Requirements (Radius & Size)

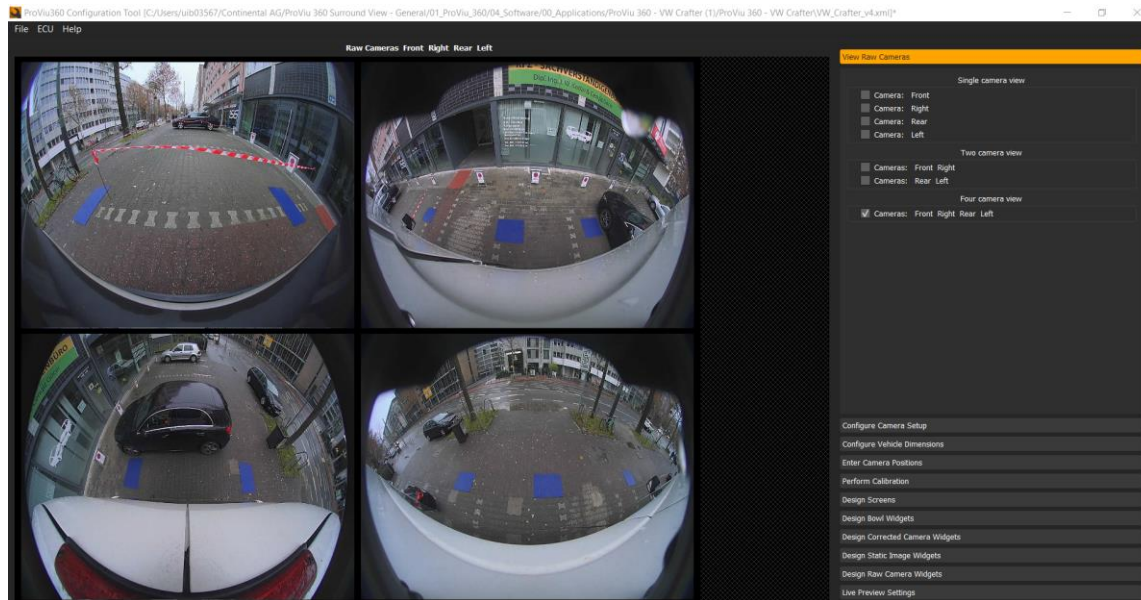
ProViu®360 2nd gen Configuration Tool

- › Customized screen Designs
- › Camera calibration
- › Vehicle parametrization
- › Application Preview

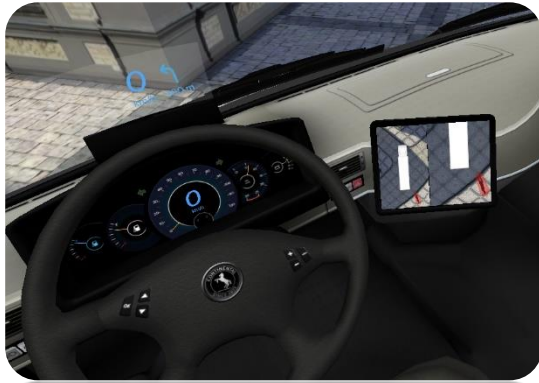
Sensor fusion

- › With Radar or other sensors communicating via CAN-Bus, distance measurements, object detection etc.

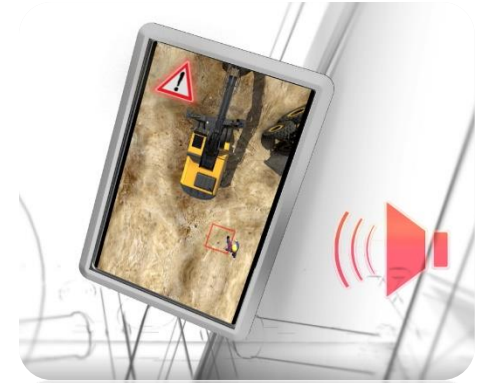
Image processing

- › Dynamic 3D views & overlays, Road based calibration, Soiling detection, Lane departure warning, Motion detection etc.
